ENGINEERING REPORT

FAA CONTRACT NO. DTFA03-02-C-00044 PHASE 1, CLIN 0001b (TASK 2) - AIRCRAFT INFORMATION REPORT

The candidate aircraft for this work is Boeing 727-232 line number 1000, registration number N474DA. This specific aircraft was chosen because its 59,497 accumulated cycles are very close to the 727 Design Service Goal of 60,000 cycles. In addition, N474DA retired before the lap joint cracking that is the subject of Boeing Service Bulletin 727-53A0222 and AD 99-04-22 was discovered in service. Therefore, although N474DA is well beyond the 35,000 cycle threshold in 727-53A0222 for NDT inspections, no lap joint NDT inspections or repairs were accomplished during service.

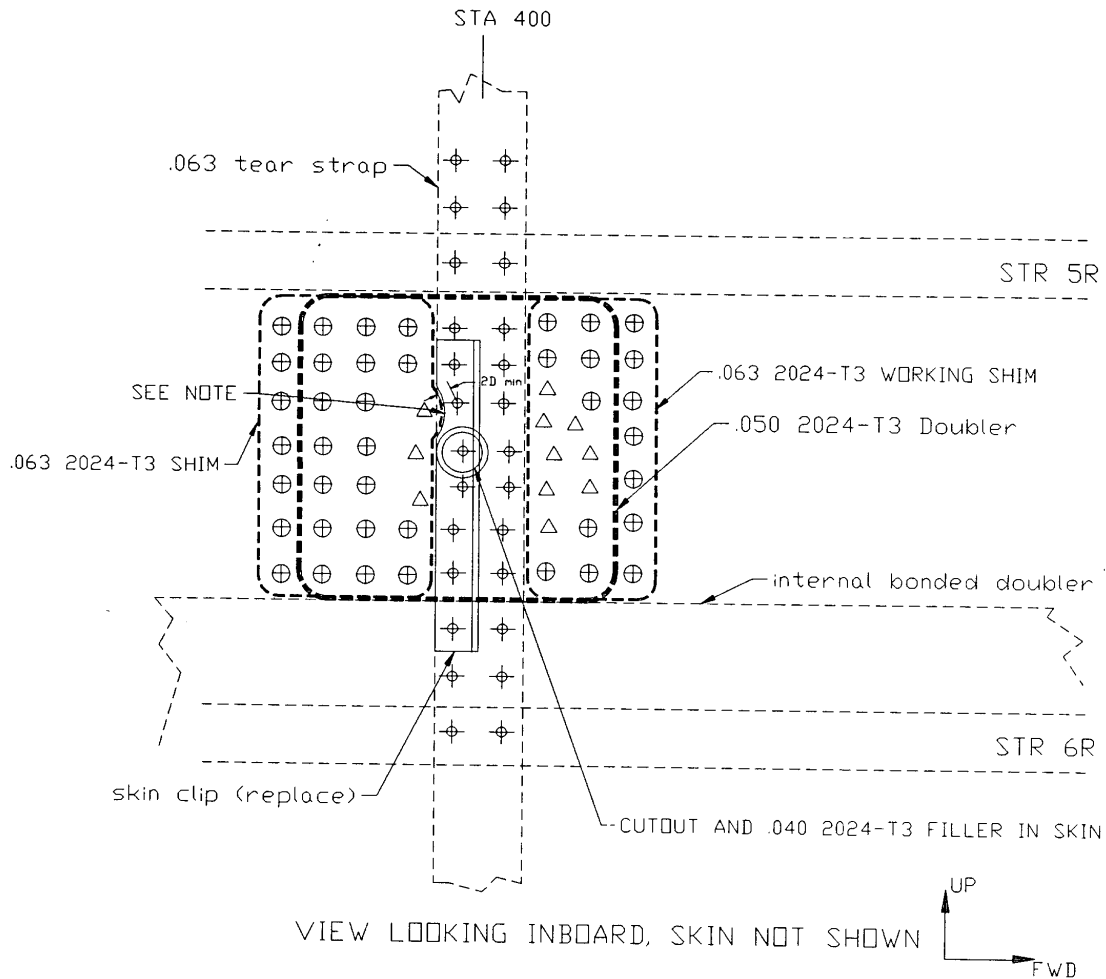
NOTE: AT LOCATIONS WHERE PREVIOUS REPAIR RIVETS CREATED SHORT EDGE MARGIN IN TEAR STRAP, TRIM THE EDGE OF STRAP TO ALLOW RIVET TAIL TO SEAT MAINTAIN 2D MINIMUM EDGE MARGIN WITH ALL OTHER FASTENERS.

- ⊕ NEW FASTENER LOC'N, INSTALL MS20470DD5
- ⊕ EXISTING FASTENER LOC'N, INSTALL SAME TYPE AS REMOVED (NAS1097DD6)
- △ TEMP. REPAIR FASTN'R LOC'NS, INSTALL MS20470DD5 RIVETS

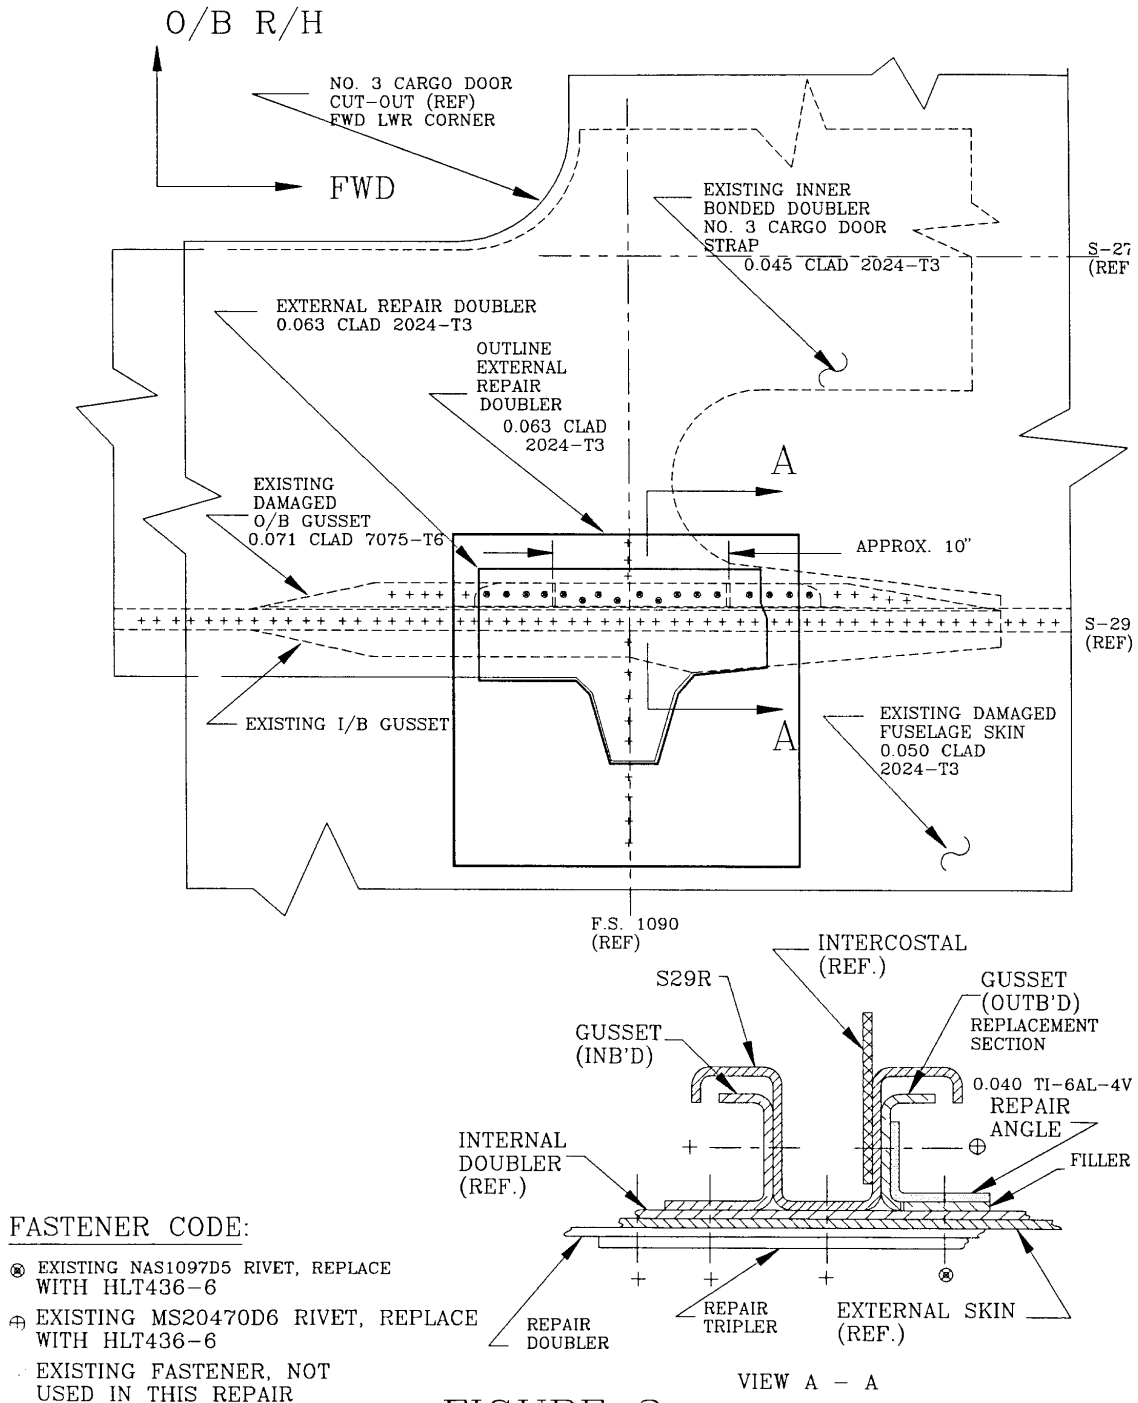
Repair Figure 2, 235329-14 (Fuselage Skin and Intercostal)

FIGURE 2
REPAIR OF GUSSET AT S-29R

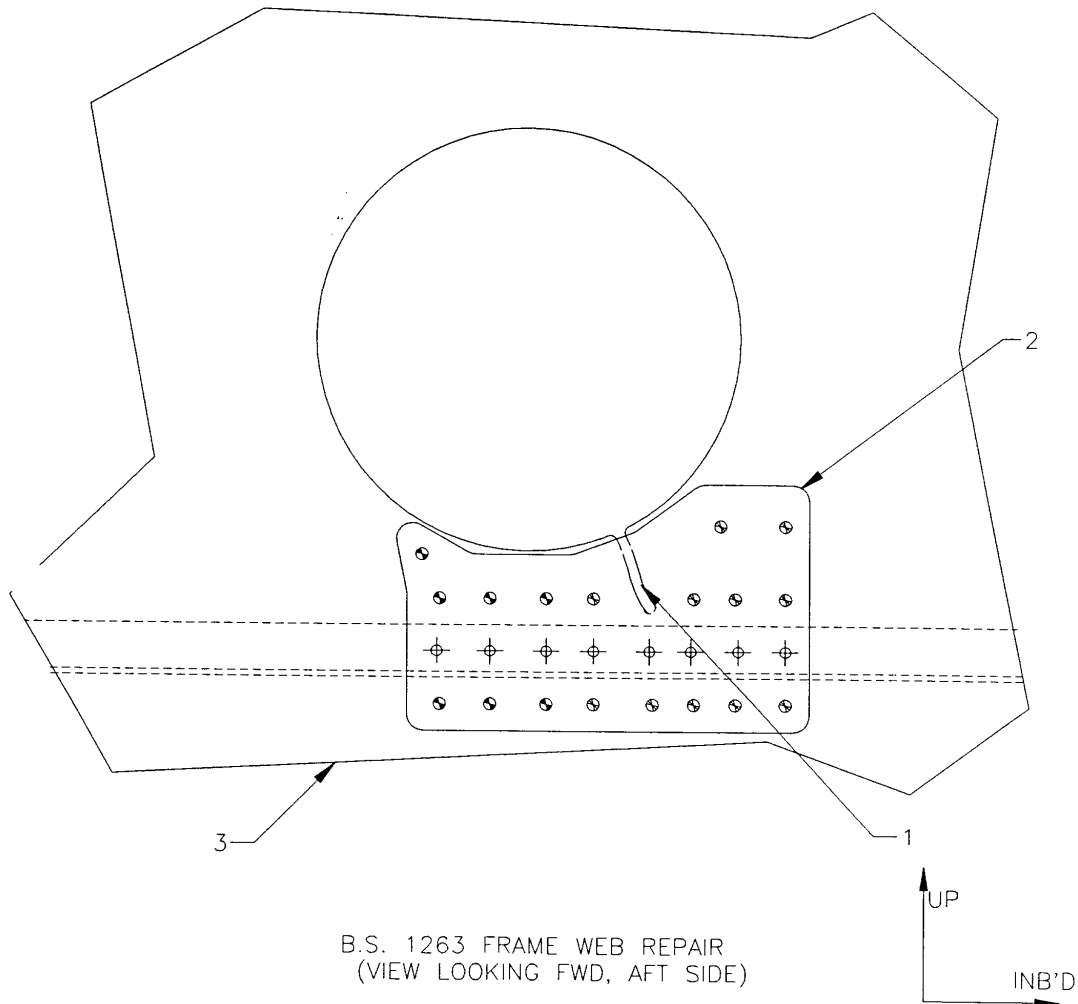
- 1 - SLOTTED CRACK, 0.25" WIDE
- 2 - 0.032 7075-T6 CLAD REPAIR DOUBLER
- 3 - 0.025 7075-T6 CLAD FRAME WEB (65-15704-29 REF.)
- ⊕ - EXISTING FASTENER, INSTALL MS20470DD5 RIVET
- - ADDED FASTENER, INSTALL MS20470DD5 RIVET
